Manhole Inspection Summary

Manhole # S19G__023MH

Insp Date: **10/4/07 12:29 PM**

Location Address: **2111 FAIRMOUNT-BALTIMORE**

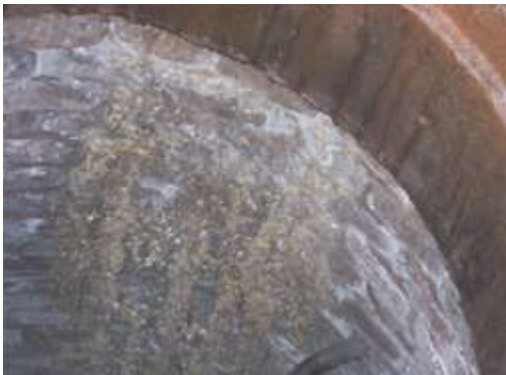
Defect 3

☒ Evidence Of Surcharge

Depth: **2** (ft.) ☐ Active Surcharge Present

EVIDENCE OF ASUR

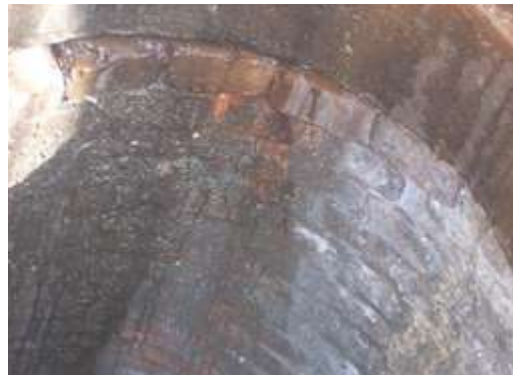
Defect 2

Infiltration: ☐ None ☐ Joint ☐ Cracks ☐ Mortar ☐ Roots ☒ Wall

INFILTRATION AT CORBEL WALL

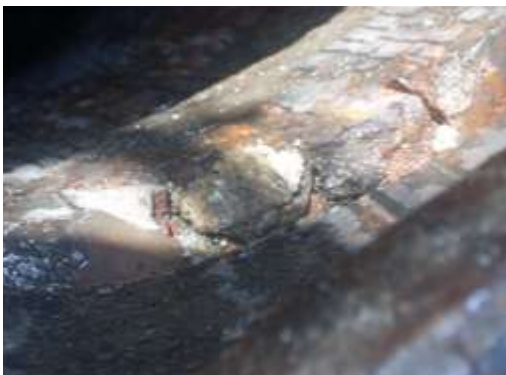
Defect 1

Offset: **1** (in.)

FRAME OFFSET

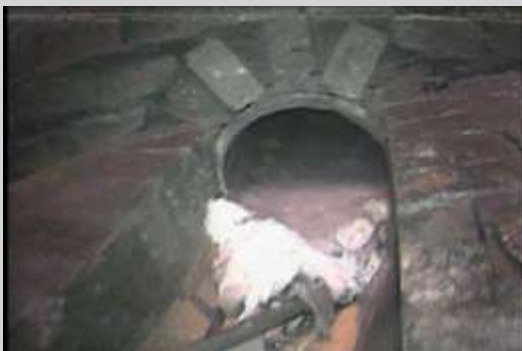
3 O'Clock Inflow

Pipe Height: **7.2** (in.) Rod and Bar (Angled)
Pipe Material: **Clay** ☐ Pipe Lined
Invert Depth: **9.09** (ft.) Flow Characteristics: **Slow**
Deposits: ☐ None ☐ Mud ☐ Sludge ☒ **Debris** ☐ Grease
Silt Depth: **4** (in.) Deposits Extent: **Medium**
Infiltration: **None** Pipe Seal Cond: **Sound**
